Results of Wear Evident in the Gun Barrel Bore of the Leopard 2A4 Main Battle Tank

Aleksander J. WASILEWSKI^{*1}, Ryszard B. WOŹNIAK²,
Janusz WEISS¹, Józef GACEK²

¹*Military Institute of Armament Technology*

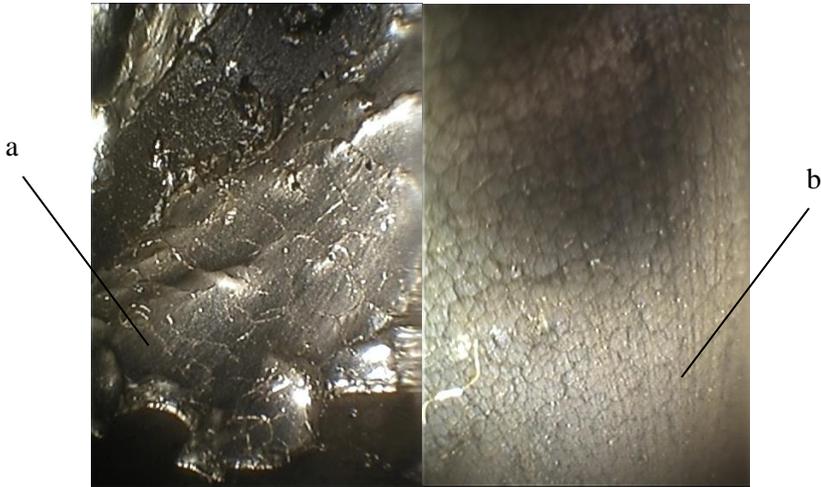
The tested gun barrel #1 had a total of 635 shots fired, with 333 shots of HE ammunition, 225 shots of APFSDS-T ammunition (filled with German-made propellant powder), and 77 shots of APFSDS mock projectile ammunition.

Test result: the section downstream the free bore (Photo 2) featured (a) evidence of heavy purging of the bore surface with spalling and cracks, and (b) evidence of an extensive heat crack lattice.

Photo 2. Condition of the full-calibre bore section downstream of the free bore (gun barrel #1)

According to [1], the barrel failed to meet the ballistic performance criteria and continued firing might compromise the safety of the tank gun crew.

1. The analysis of the test results for the Rh-120 L44 gun barrels revealed that the ballistic performance of gun barrel #1, which had fired 635 projectile rounds, and gun barrel #2, which had fired 684 projectile rounds, deteriorated to a level which would compromise the safety of the crew. It was decided to decommission both gun barrels.

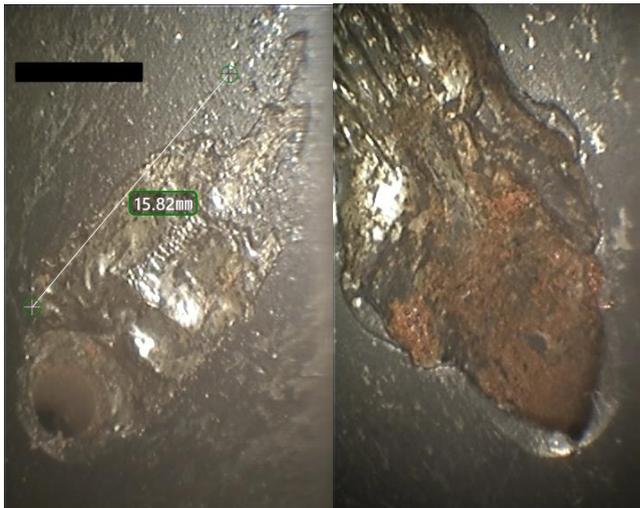
The section in the area of the bore evacuator ports featured erosion indications in the form of purging and delamination of the bore surface. The erosion indications were approx. 15 mm in length (Photo 3).

Photo 3. Condition of the bore evaluator port area (gun barrel #1)

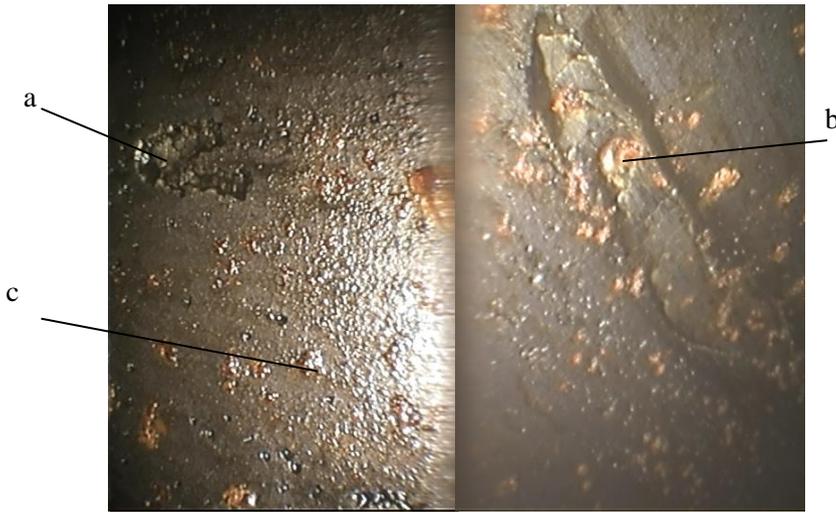
The tested gun barrel #2 had a total of 684 shots fired, with 248 shots of HE ammunition, 320 shots of APFSDS-T ammunition, and 116 shots of HE mock projectile ammunition.

Test result: the section downstream the free bore (Photo 4) featured (a) very evident indications of pitting and cracks with many indications of spalling and purging; the recessed revealed (b) indications of corrosion. Multiple (c) blisters and (b) splinters were also found.

Photo 4. Condition of the full-calibre bore section downstream of the free bore (gun barrel #2)

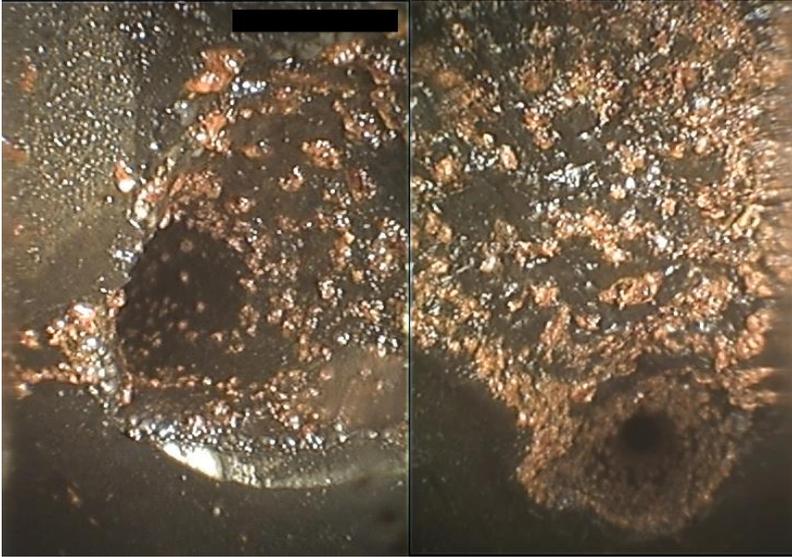
The section in the area of the bore evacuator ports featured readily visible evidence of irregular purging. Here, evidence of highly advanced corrosion was found. Directly at the bore evacuator ports, visible defects of material were found (Photo 5). The damage found in gun barrel #2 disqualified it from continued service.

Photo 5. Condition of the bore evaluator port area (gun barrel #2)

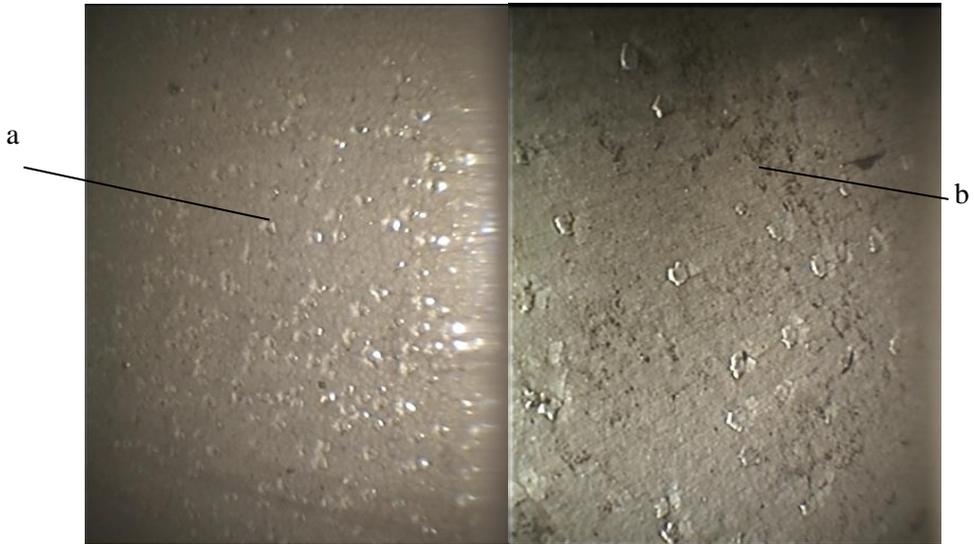
The tested gun barrel #3 had a total of 535 shots fired, with 189 shots of HE ammunition, 261 shots of APFSDS-T ammunition, and 85 shots of assorted HE mock projectile ammunition types.

Test result: the section downstream the free bore (Photo 6) featured evidence of (a) spalling with (b) delamination and flaking of the barrel bore surface. There were also clear indications of a heat crack lattice. The section in the area of the bore evacuator ports (Photo 7) revealed strong purging of the bore surface with extensive cracks underneath. The geometric features of the bore evacuator ports were altered. Gun barrel #3 was in continued service at the Dynamic Testing Centre of the Military Institute of Armament Technology. A list of all shots fired with the tested gun barrels is shown in Table 2.

Photo 6. Condition of the full-calibre bore section downstream of the free bore (gun barrel #3)

2. Gun barrel #3 had fired a total of 530 projectile rounds and was found to gradually lose its specified ballistic performance. It should be expected that approximately 150 future rounds of APFSDS-T and/or HE projectiles will cause evidence of wear comparable to that in gun barrel #1 and #2.

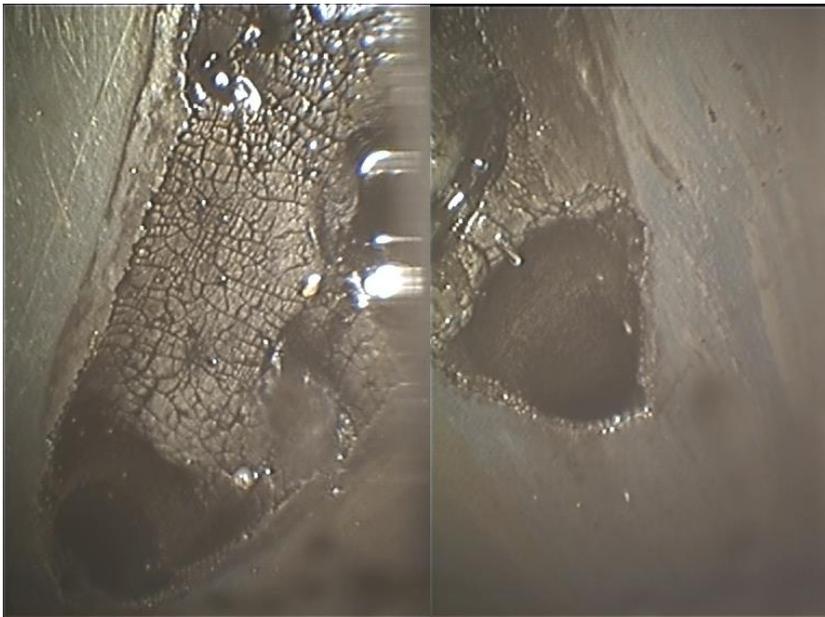
Photo 7. Condition of the bore evaluator port area (gun barrel #3)
