Results of Wear Evident in the Gun Barrel Bore of the Leopard 2A4 Main Battle Tank

Aleksander J. WASILEWSKI^{*1}, Ryszard B. WOŹNIAK²,
Janusz WEISS¹, Józef GACEK²

¹*Military Institute of Armament Technology*

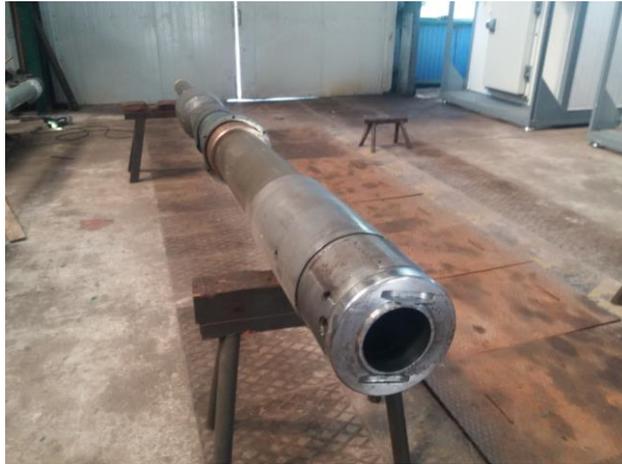
Three barrels of the Rh-120 L44 tank gun were tested (Photo 1). The test comprised a visual examination of two sections of the calibre length of each barrel bore (Fig. 1). First, the section located directly downstream of the free bore was inspected (up to 150 mm), followed by the inspection of a section within the area of bore evacuator ports (Fig. 1).

Photo 1. Rh-120 L44 gun barrel on a test rig

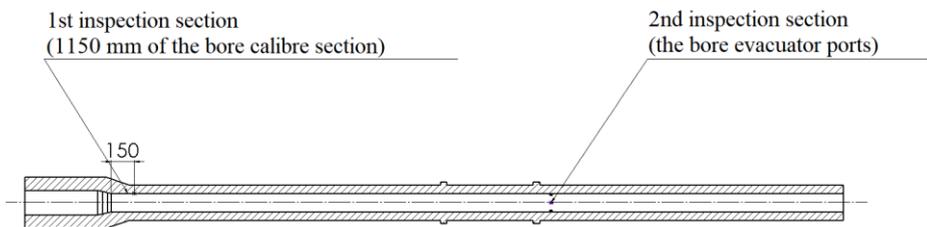
Fig. 1. Cross-sectional diagram of the Rh-120 L44 gun barrel bore with the inspection sections highlighted
